**In-Flight Electrical System Failure  
and Loss of Control  
Jet Express Services  
Raytheon (Beechcraft) Super King Air 200,  
N81PF  
Near Strasburg, Colorado  
January 27, 2001**

**National  
Transportation  
Safety Board**  
Washington, D.C.

**NTSB/AAR-03/01  
PB2003-910401  
Notation 7358A  
Adopted January 15, 2003**

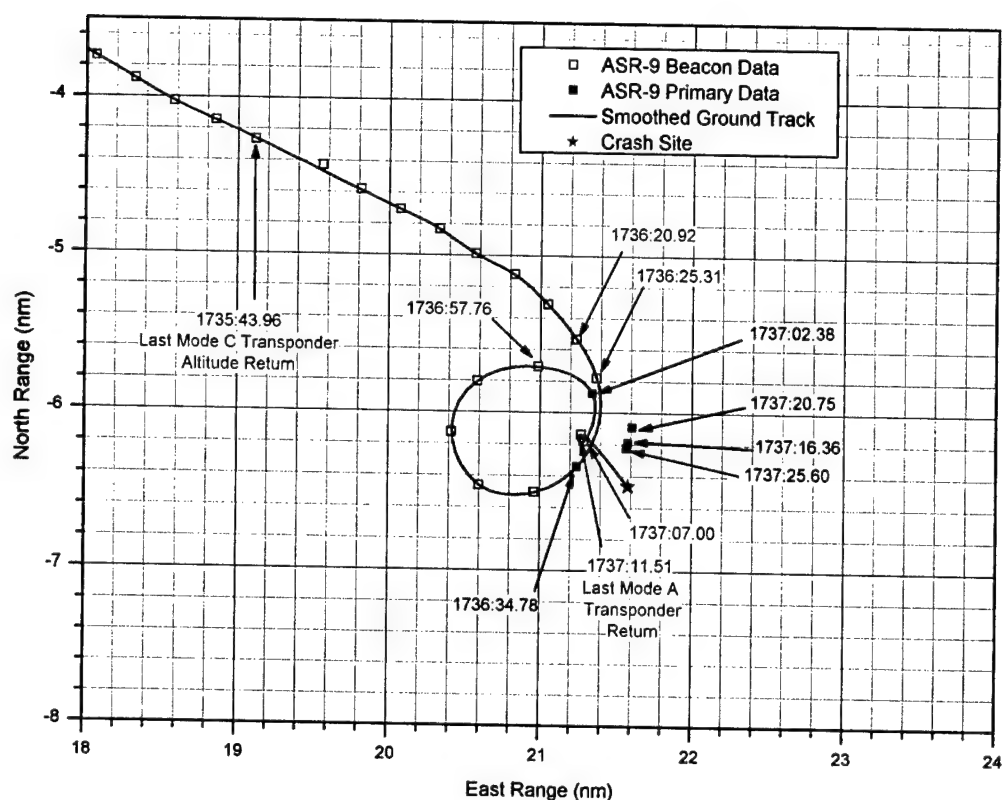
Note: Airport surveillance radar-9 (ASR-9) primary data are reflected radio signals. ASR-9 primary data returns were received until about 1737:26, about 14 seconds after the last mode A (beacon data) return. The distances shown are relative to the ASR-9 radar site at Denver International Airport.

Figure 1. Radar data for the last 2 minutes of the accident flight.

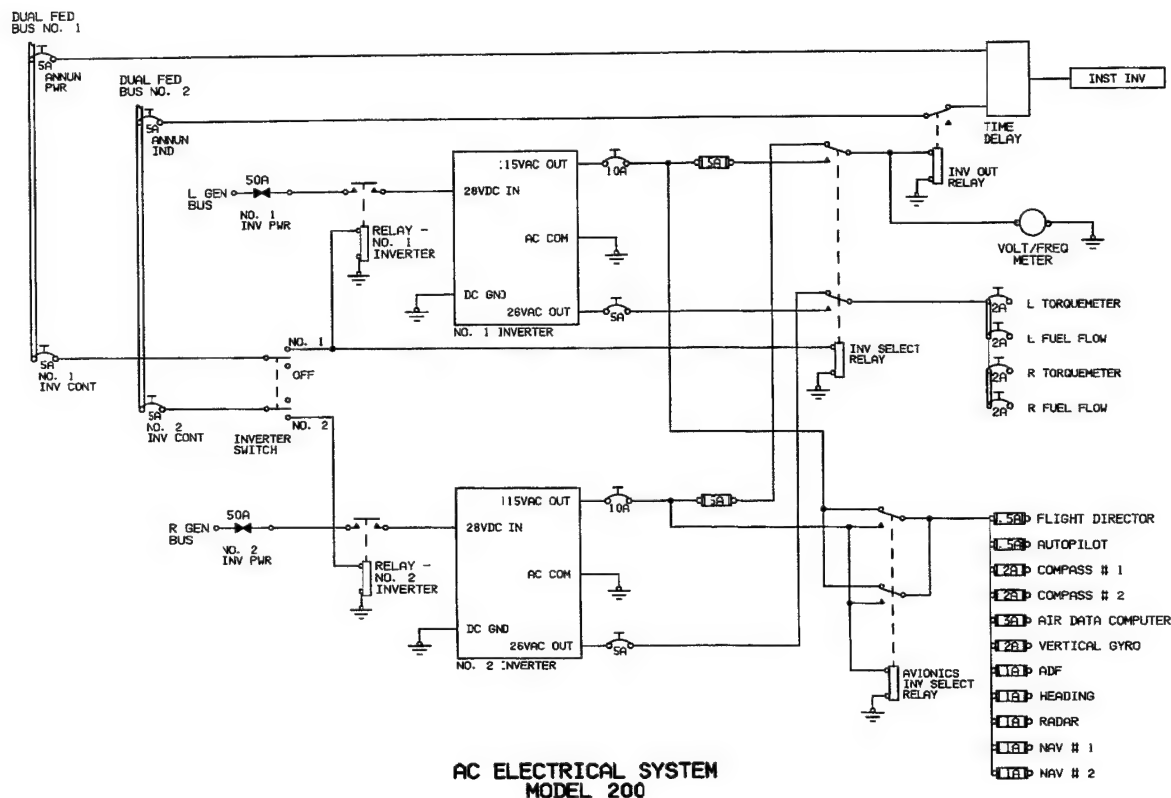
**Figure 2.** Schematic of the King Air 200 a.c. electrical system.

Third, the King Air 200 electrical system schematic indicates that, if at least one of the inverters is operational, no a.c. power is present at the volt/frequency meter, and d.c. power is available to the inverters, then one of three components—the inverter selector switch, the inverter select relay, or the avionics inverter select relay—could produce an a.c. power electrical system failure (see figure 2). Thus, all three components are potential sources of single-point failures in the electrical system. None of these items was recovered from the wreckage.
